## Waterway Inspection Report

| Date | 9-3-26 |
| Location | Century Village Boca |

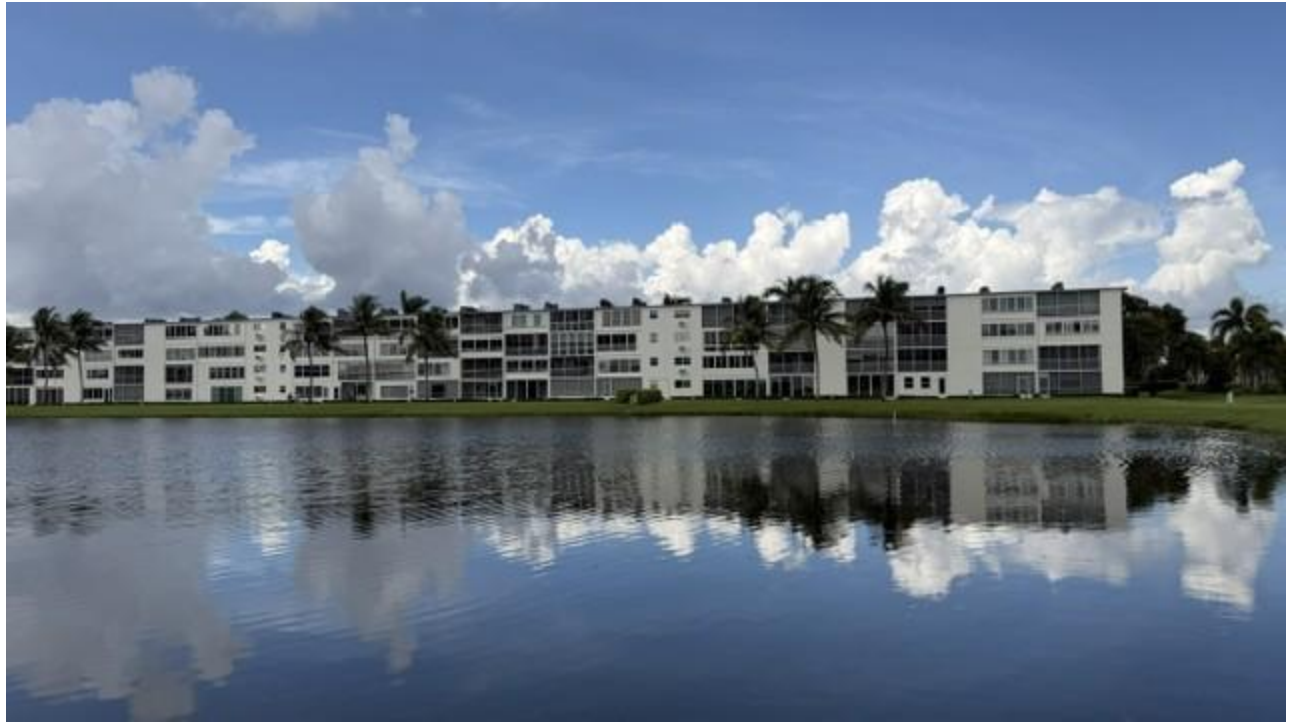
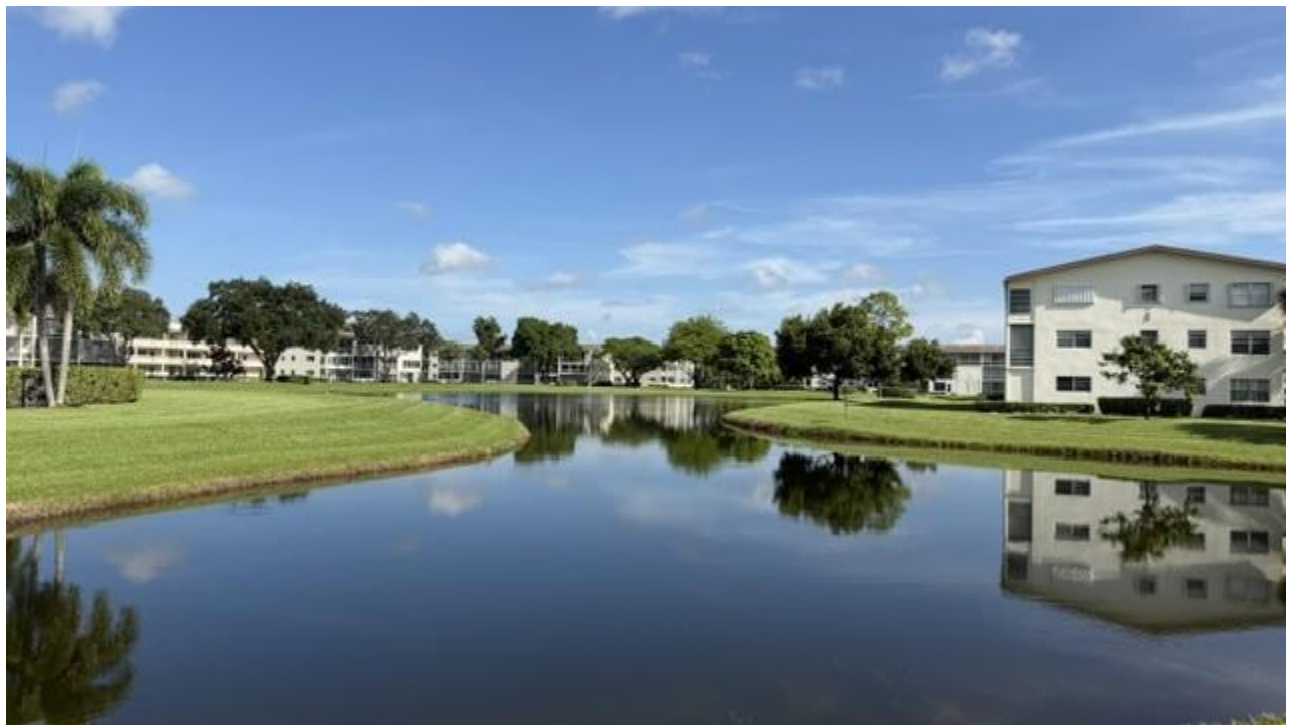
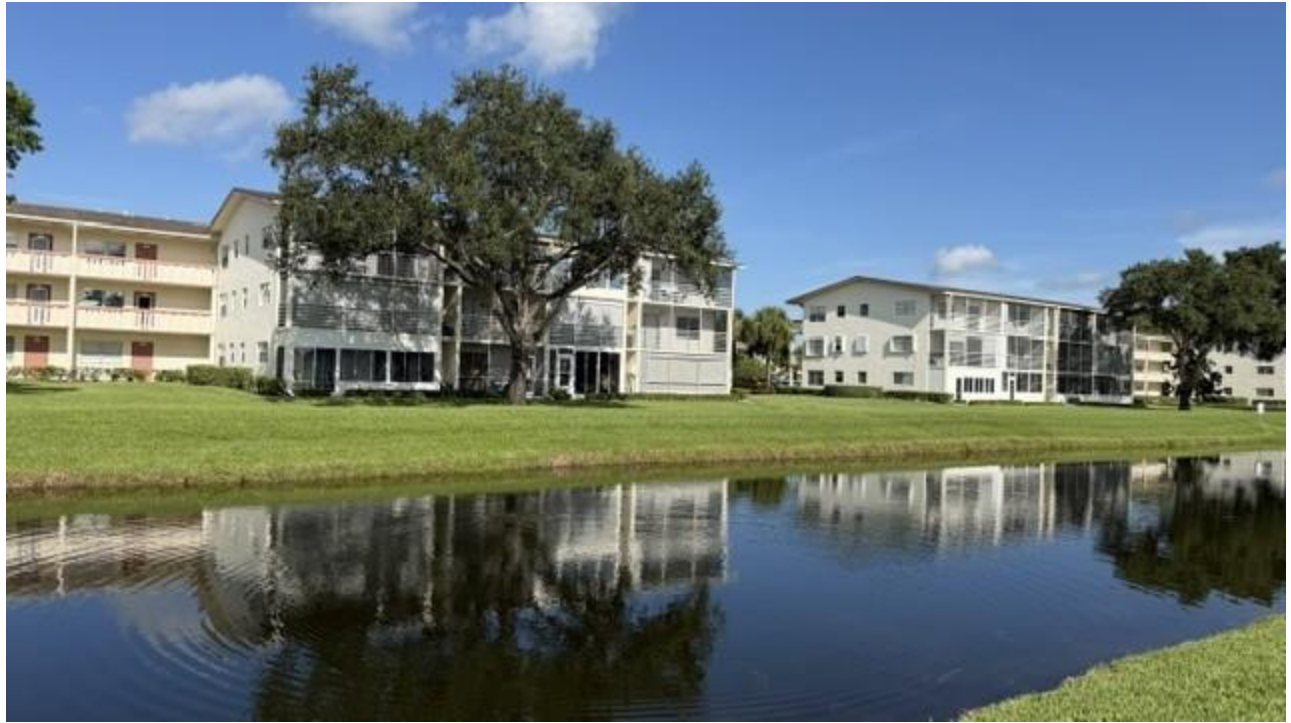
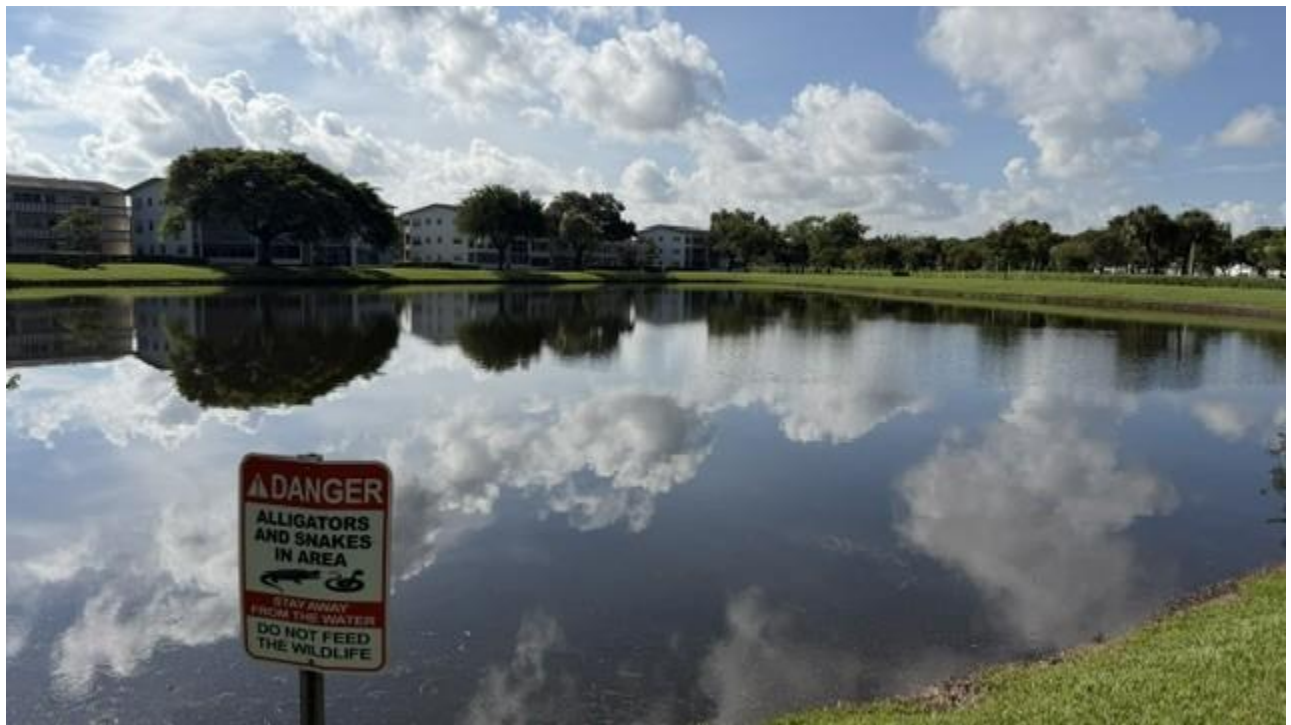
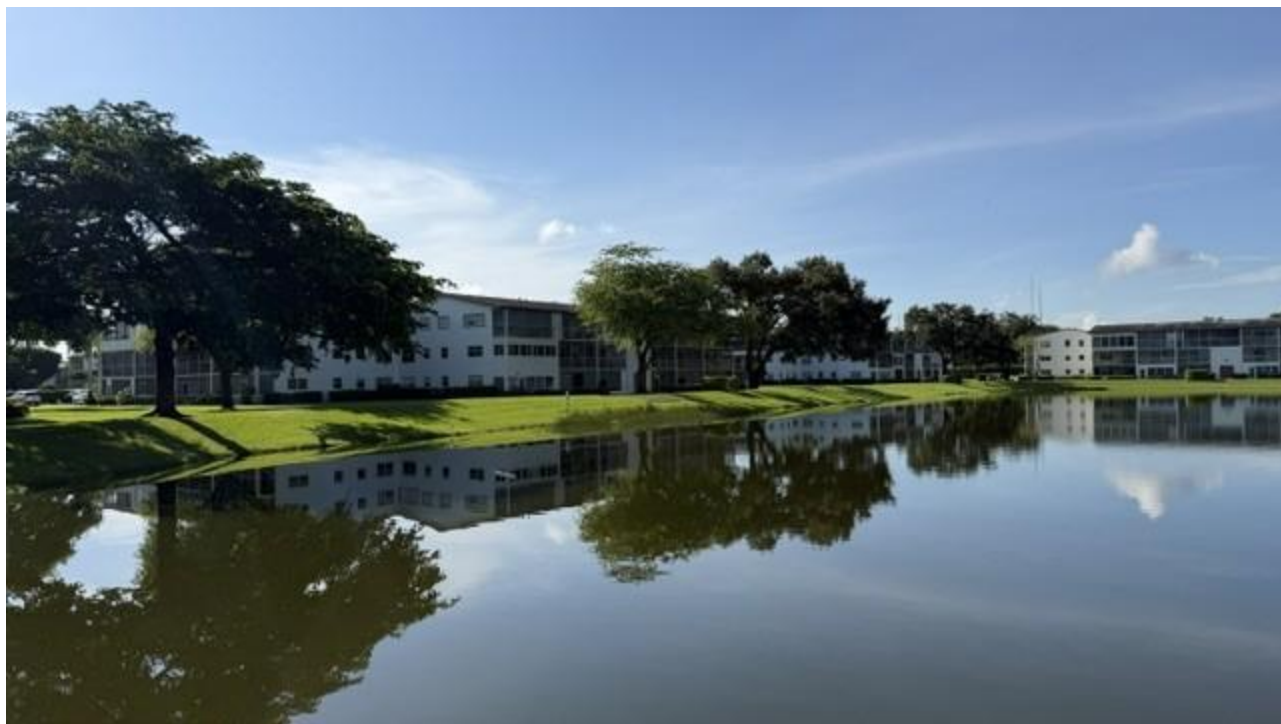
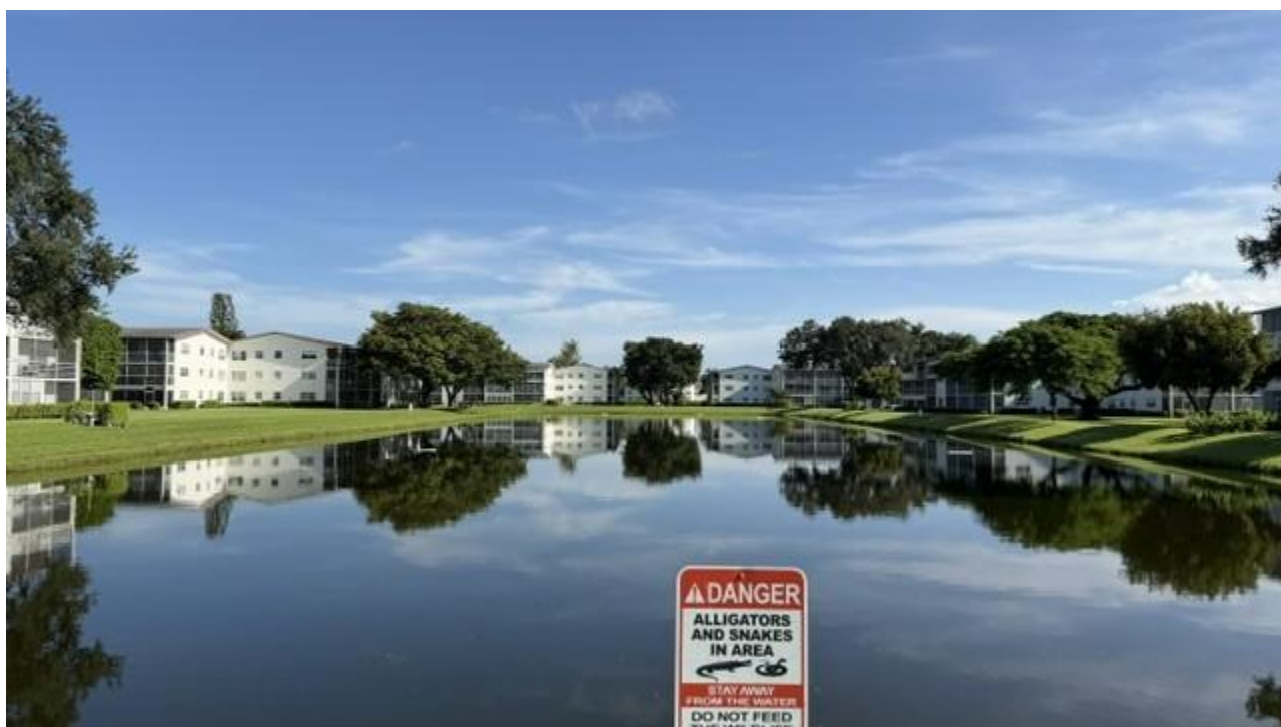
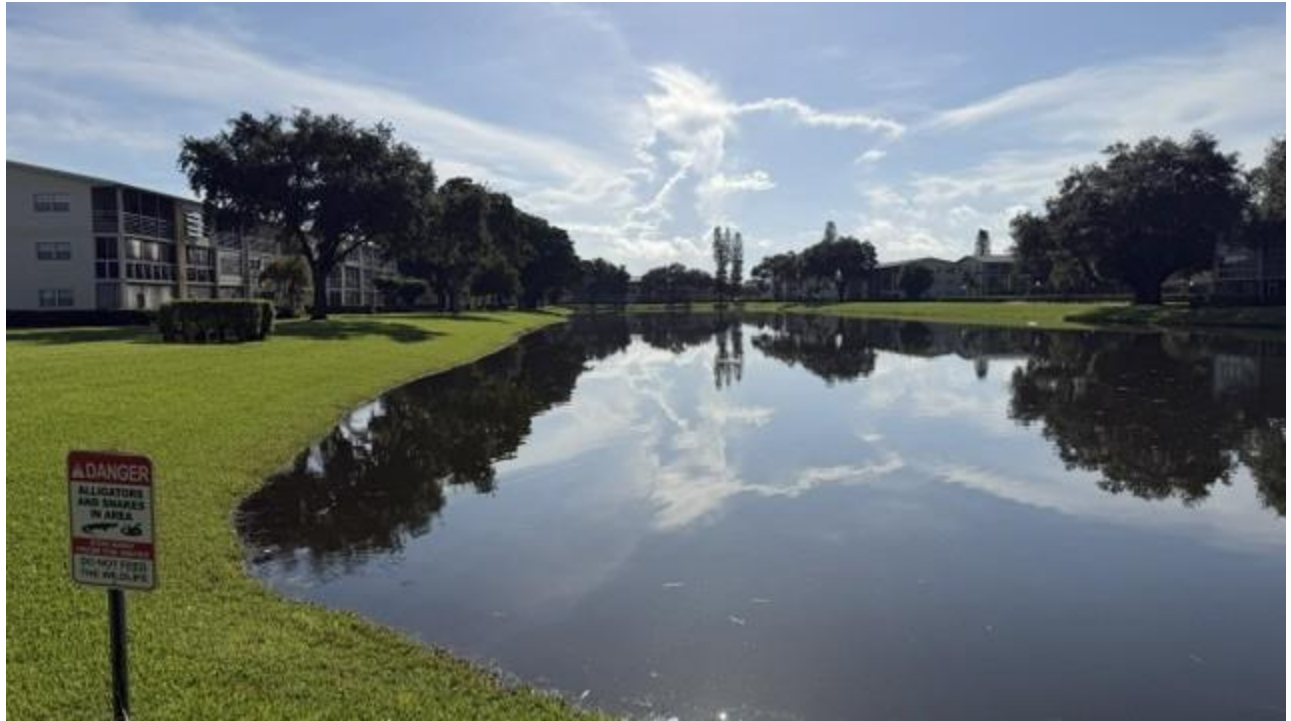
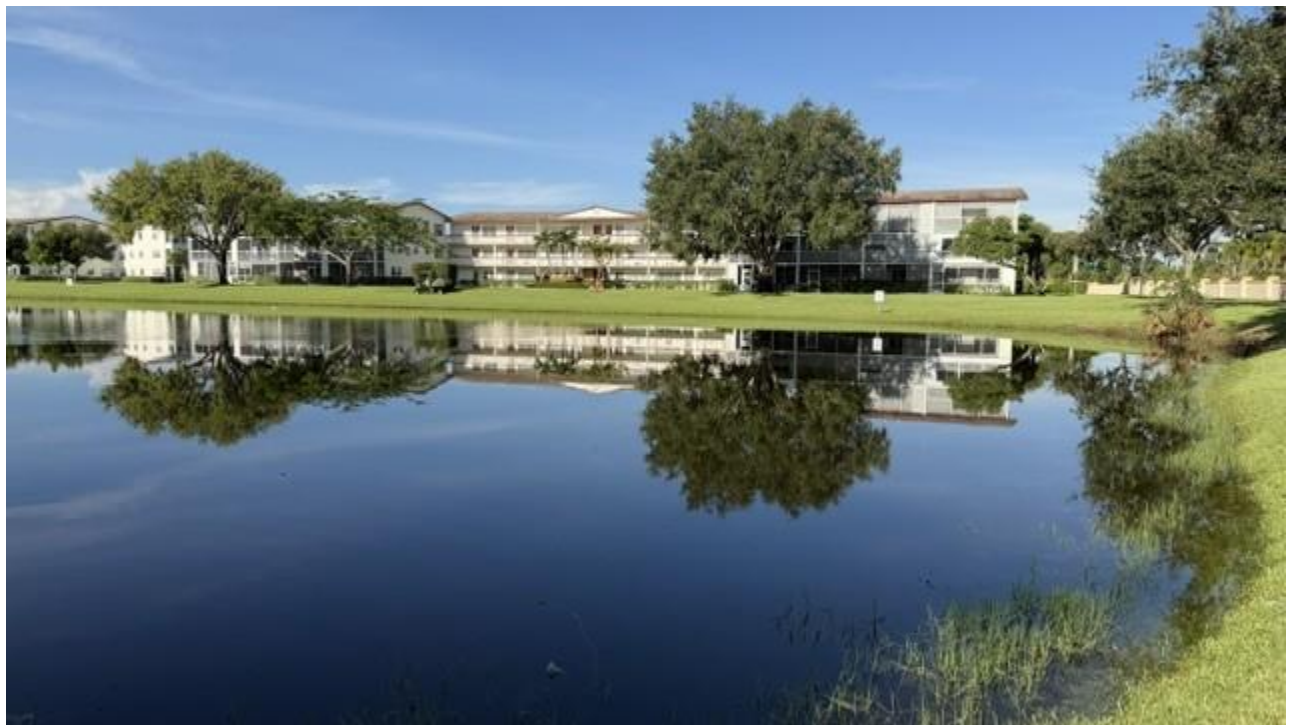
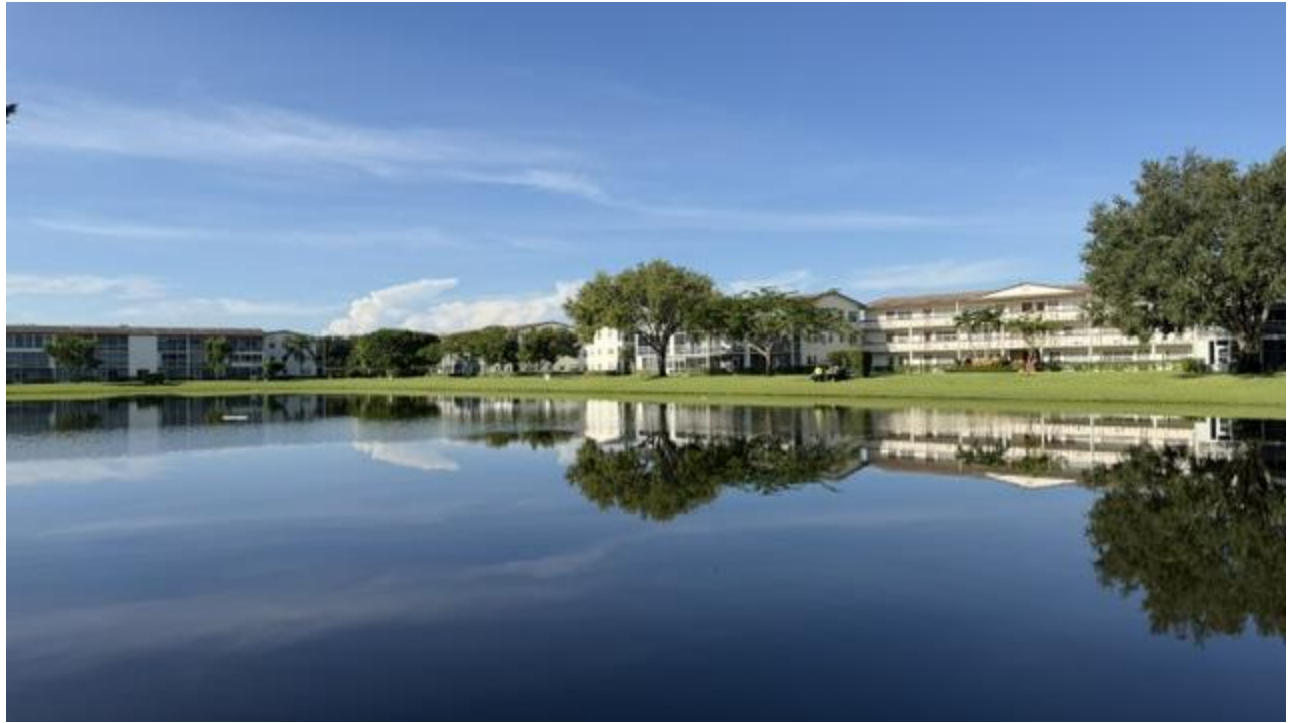
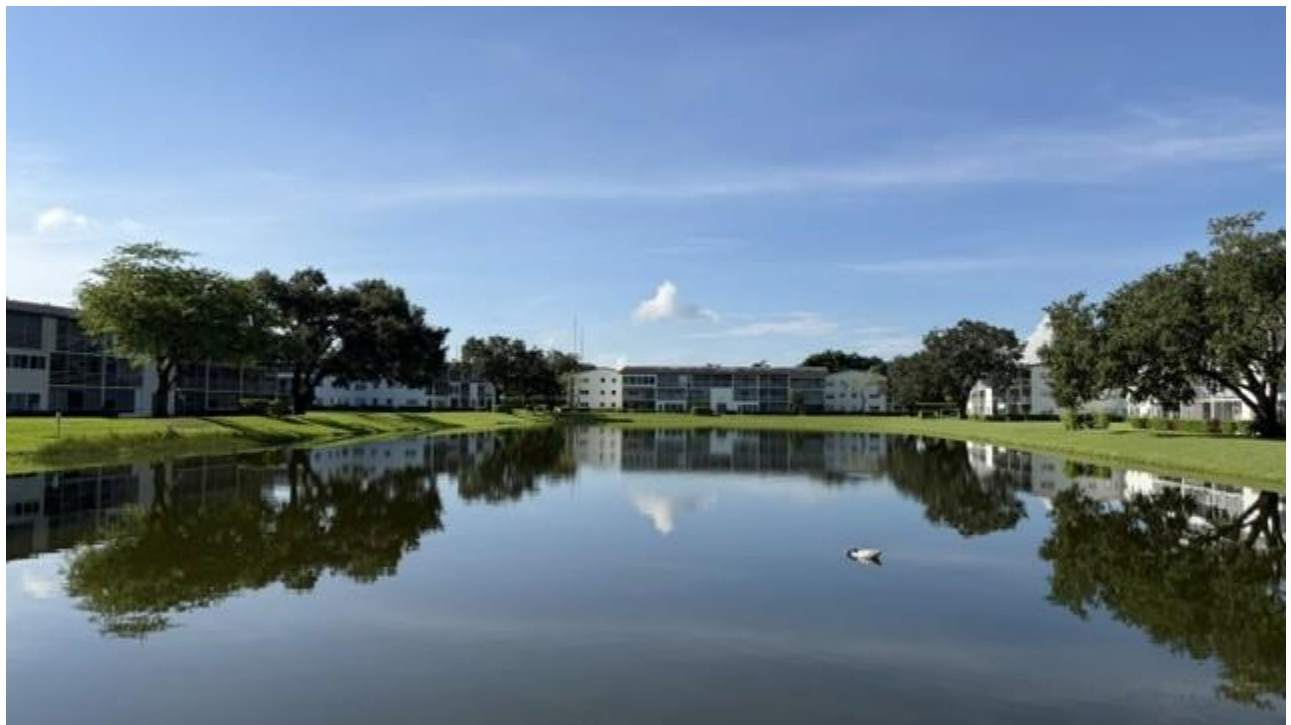
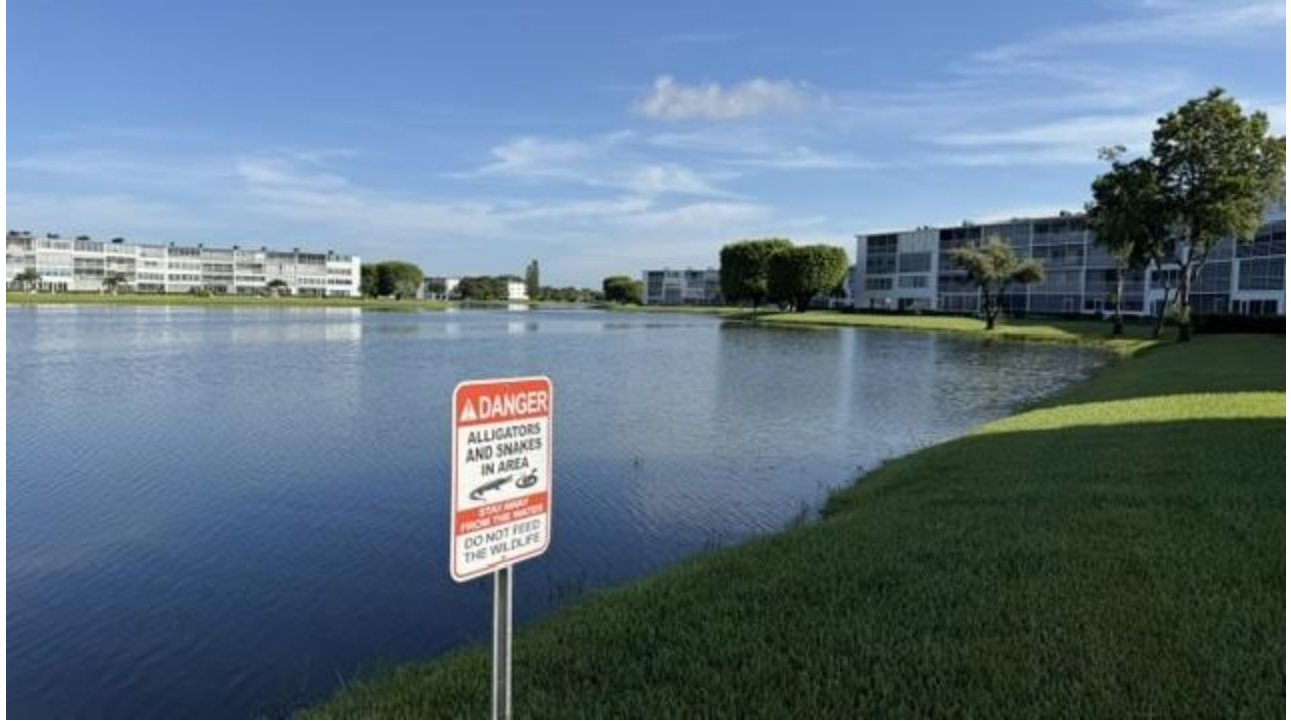
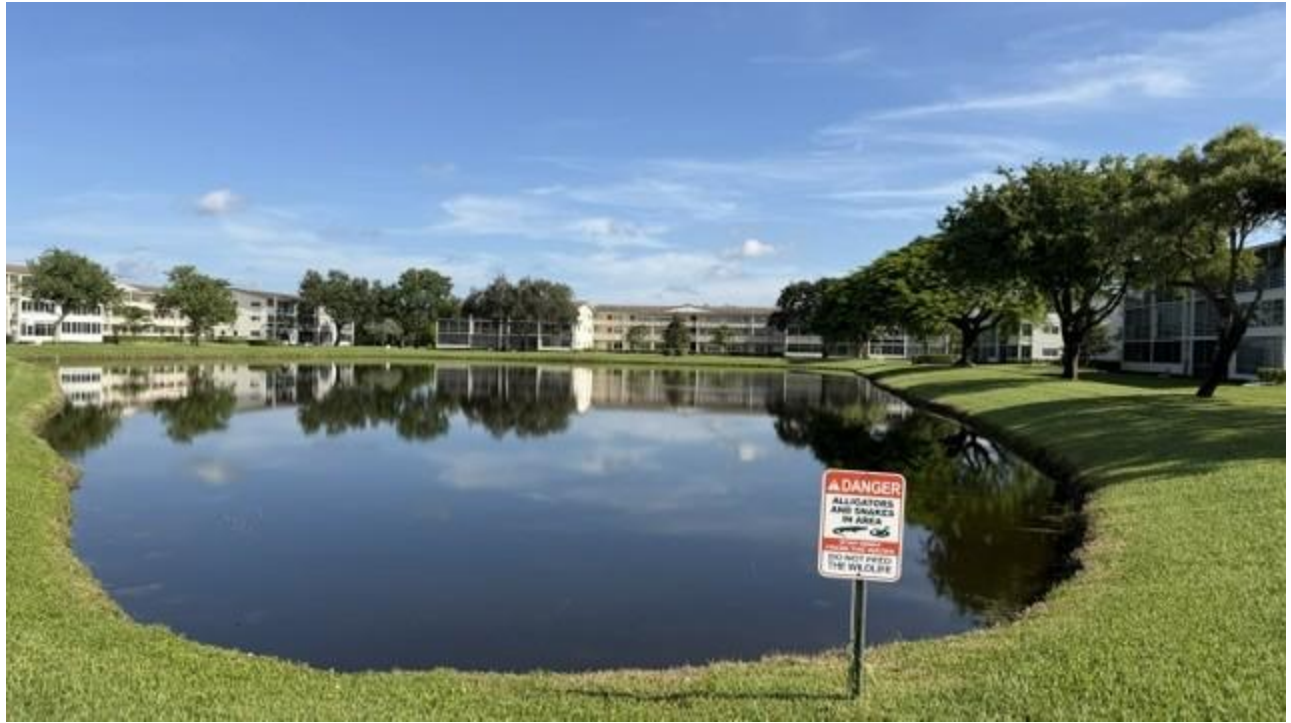
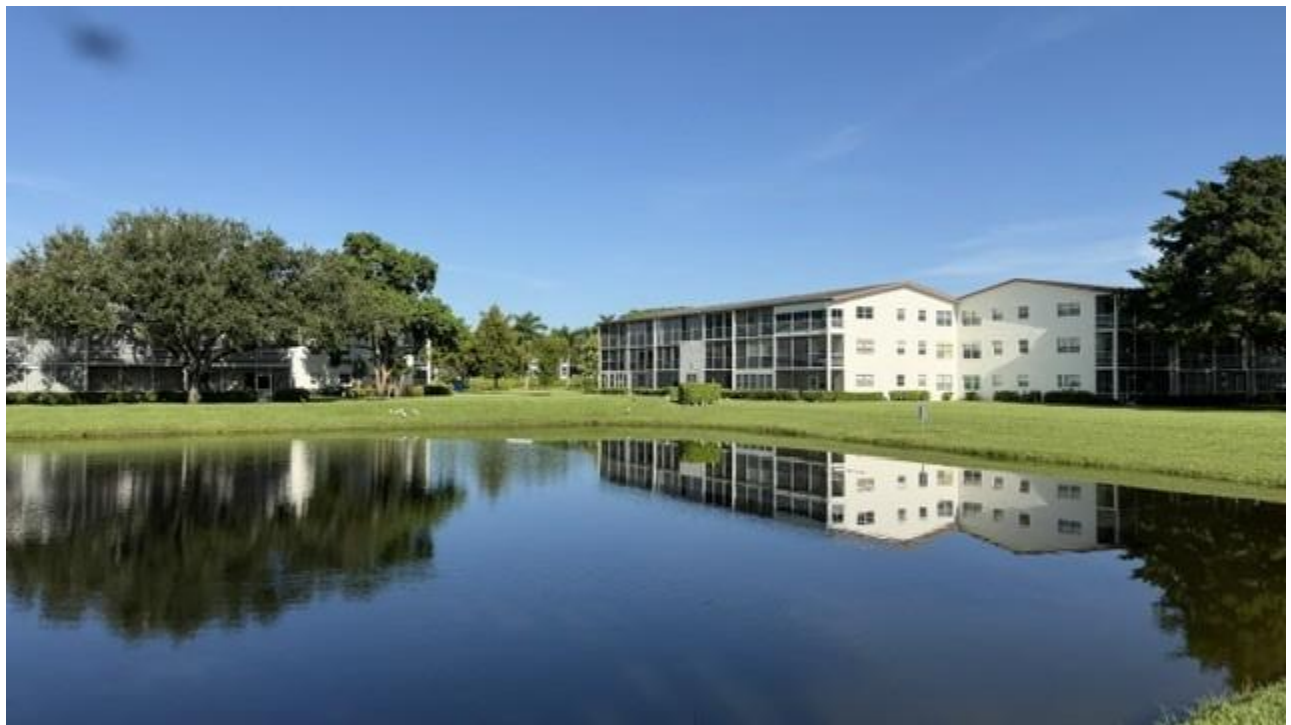
| Today we treated for shoreline grasses. No signs of surface algae at this time. Water levels are high. We also picked up debris out of big lake. All lakes are looking healthy. |
